**NBSIR 82-2465**

# **Investigation of the Kansas City Hyatt Regency Walkways Collapse**

U.S. DEPARTMENT OF COMMERCE  
National Bureau of Standards  
Washington, DC 20234

February 1982

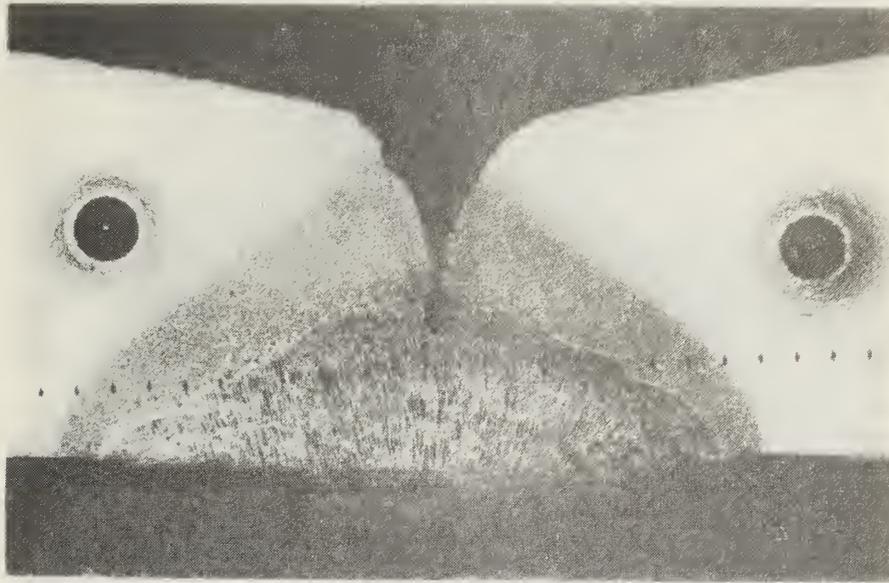
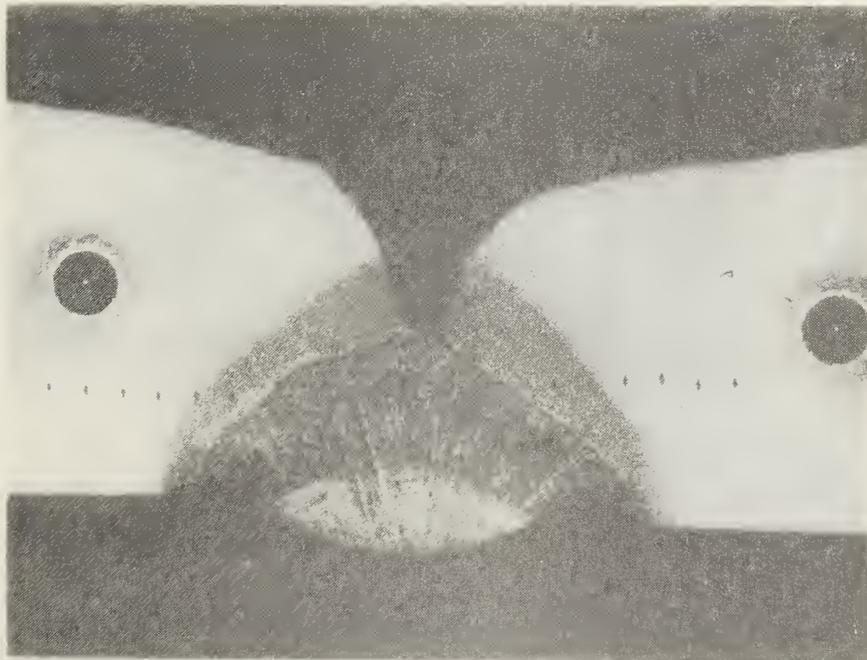
Figure 7.10 illustrates the appearance of an NBS weldment made by the GMAW process, while figures 7.11-7.13 illustrate the appearance of weld regions in box beams 9U, 8L and 9M, respectively. Basic walkway weldment hardnesses were normal. Maximum hardnesses were 92-95 Rockwell B (HRB) for the weld regions, 85-93 HRB for the heat-affected zones and 70-79 HRB for the unaffected parent metal. Small zones of increased hardness (28-33 HRC) were noted in the heat-affected zones of one section taken from location 9U and one section taken from location 8L. The structure of the hard zones appeared to be tempered martensite.

Figures 7.10 to 7.13 illustrate a substantial variability in the contour of the mating flange ends forming the faying surfaces for welding. The effect, coupled with differences in weld penetration, creates regions of varying notch acuity in the weld region. However, no cracks were observed to have initiated from such notches in any of the sections studied.

Figure 7.12 Cross sections through weld regions of box beam 8L. Sections were separated about 7.5 in (190 mm) along the beam length. Microhardness indentations traverse the surfaces. X8 1/2

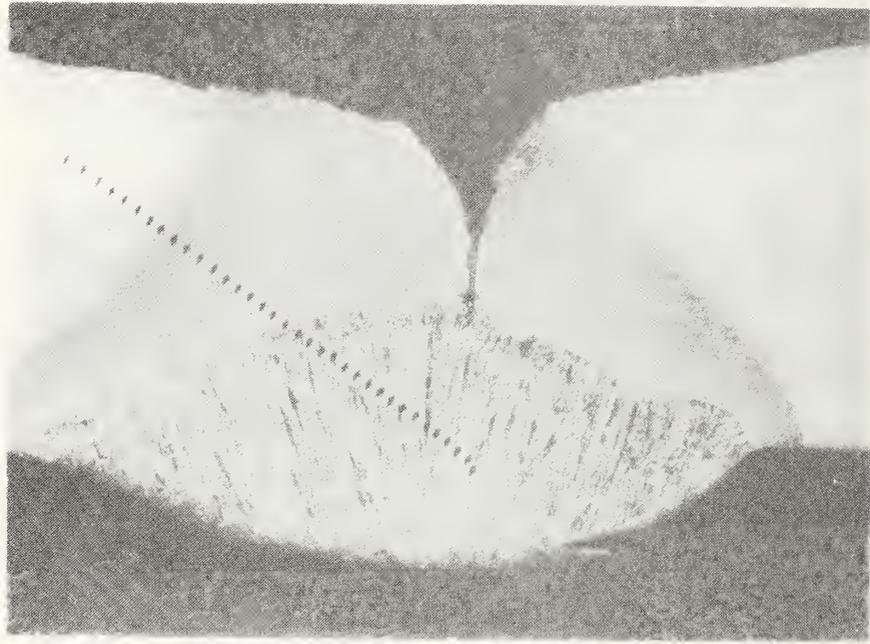
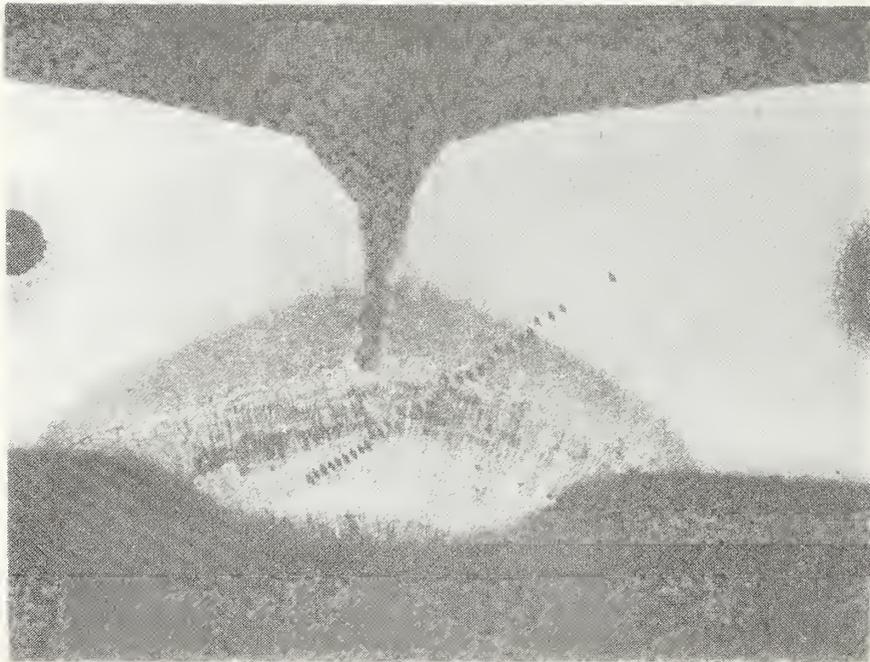
Figure 7.13 Cross sections through weld regions of box beam 9M. Sections were separated about 7.5 in (190 mm) along the beam length. Microhardness indentations traverse the surfaces. X8 1/2

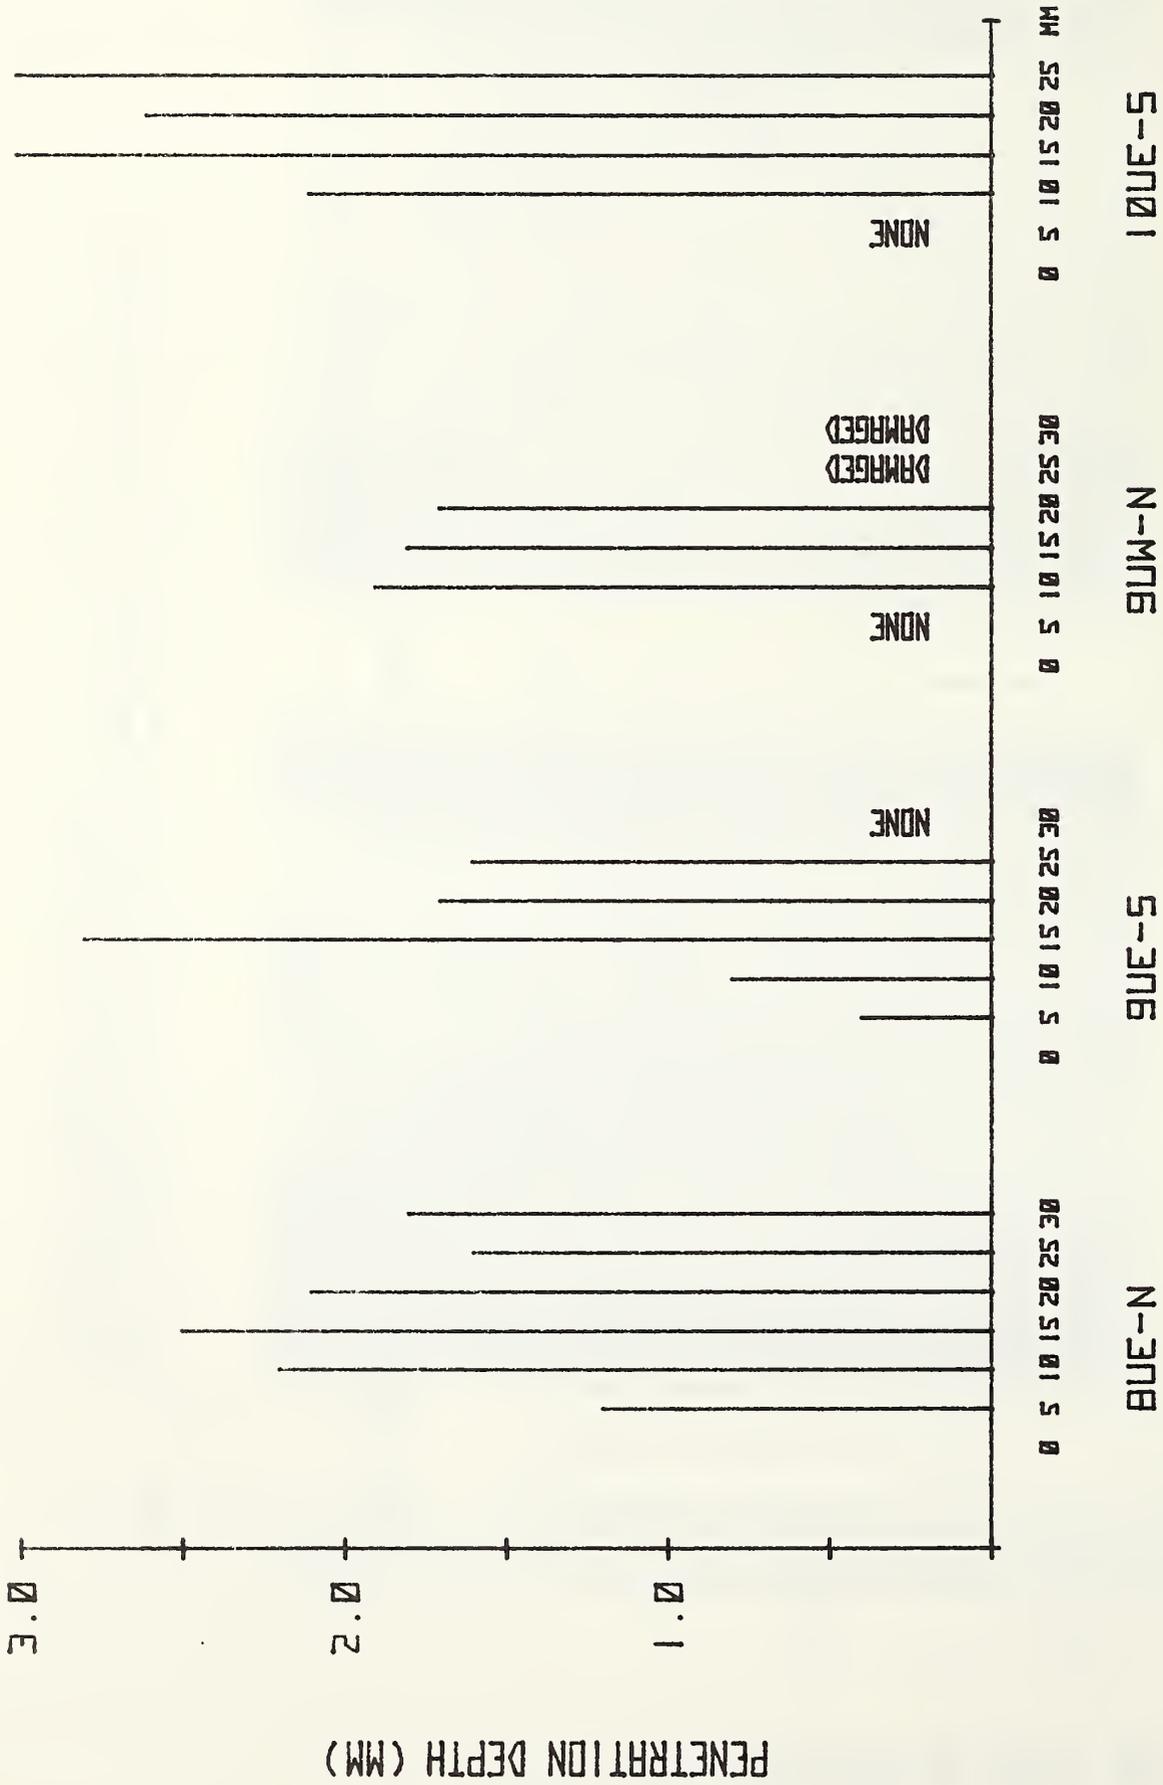
Figure 7.15 Overall depth of interior tack welds measured from fractures with data points reflecting equally spaced measurements from beam end (left) to hanger rod hole (right). NONE indicates no tack weld at that location.

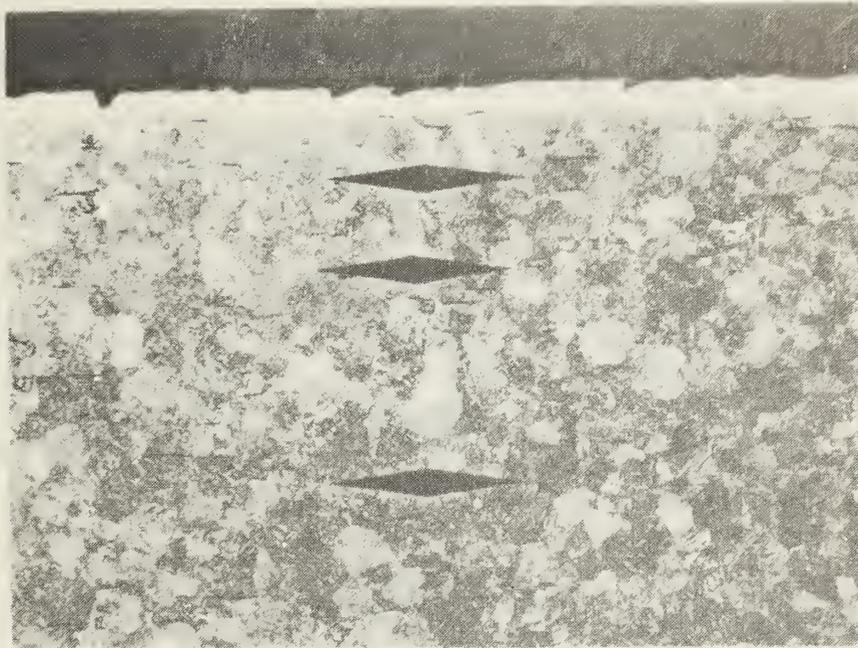
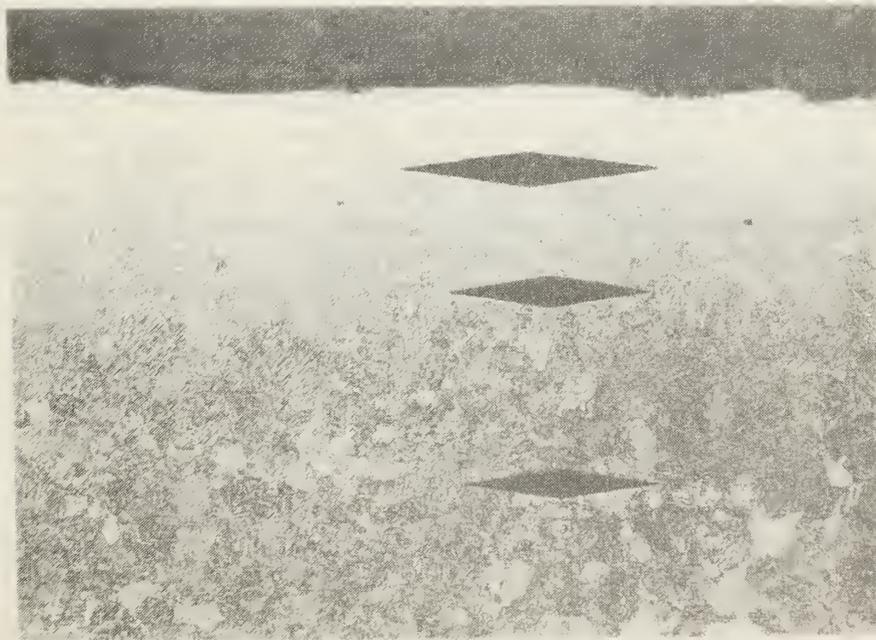
Figure 7.16 Microstructures of washers from 9MW (NBS specimen 3), (a), and of hardened washer used in NBS tests, (b). Whiter layer near surface (top of illustrations) is decarburized layer. Interior structure is tempered martensite. Etchant: Picral. X200

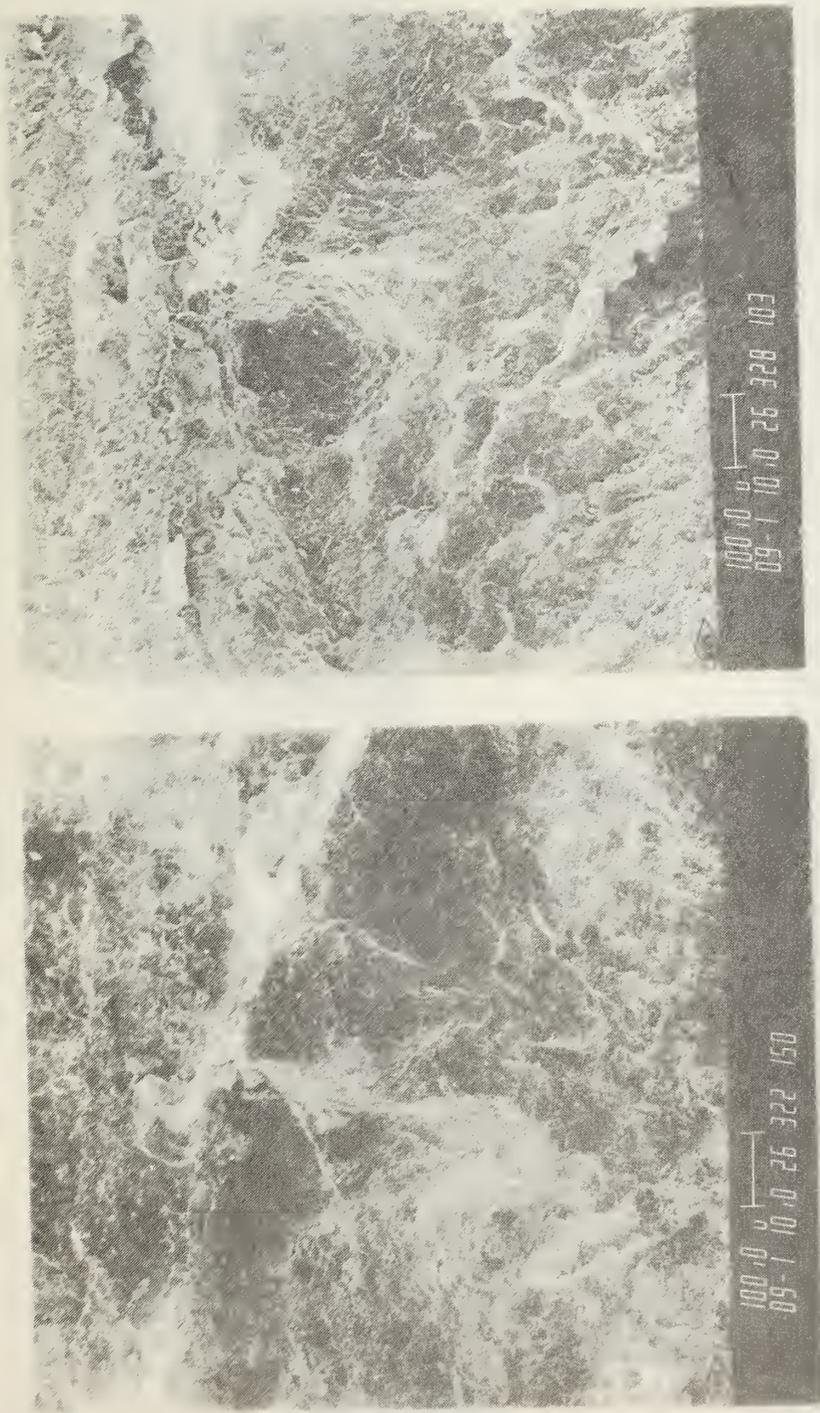
Figure 8.1 Comparison of quality of image by direct SEM (a) and by replication (b) where replica contact is ideal. Fracture surface is located at root of upper exterior longitudinal weld of walkway box beam at location 8UW (north). Magnification X100.

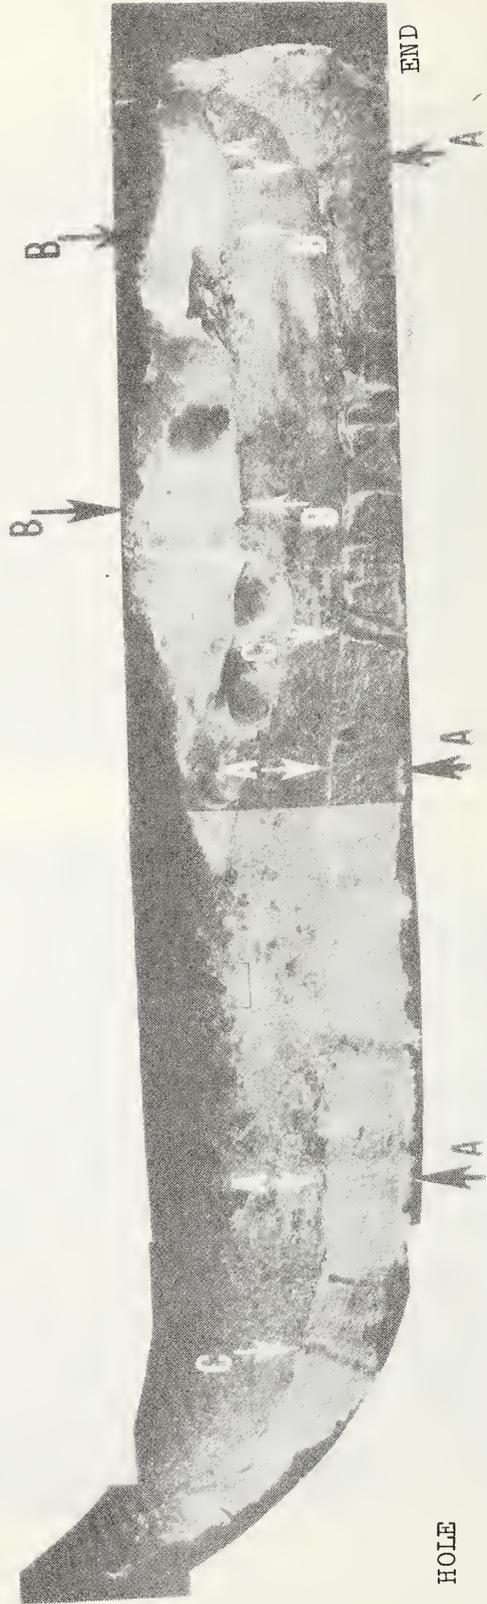
Figure 8.2 illustrates that the gross features of the fracture in the lower longitudinal weld between the outer hanger rod hole and beam end of box beams tested to failure were similar, regardless of whether the beam had been fabricated at NBS or had been obtained from the walkway debris. Rounded and piping porosity are evident in both fractures. The sharply delineated weld region in these figures indicates the absence of rust on the freshly fractured surfaces.

Figure 8.2 One half of box beam fracture surface between beam end and outer hanger rod hole for NBS fabricated box beam K2 (a) and for walkway box beam 9M tested at NBS (b). Exterior longitudinal weld indicated by arrows A, interior tack weld indicated by arrows B, examples of piping porosity indicated by arrows C. Magnification X6.

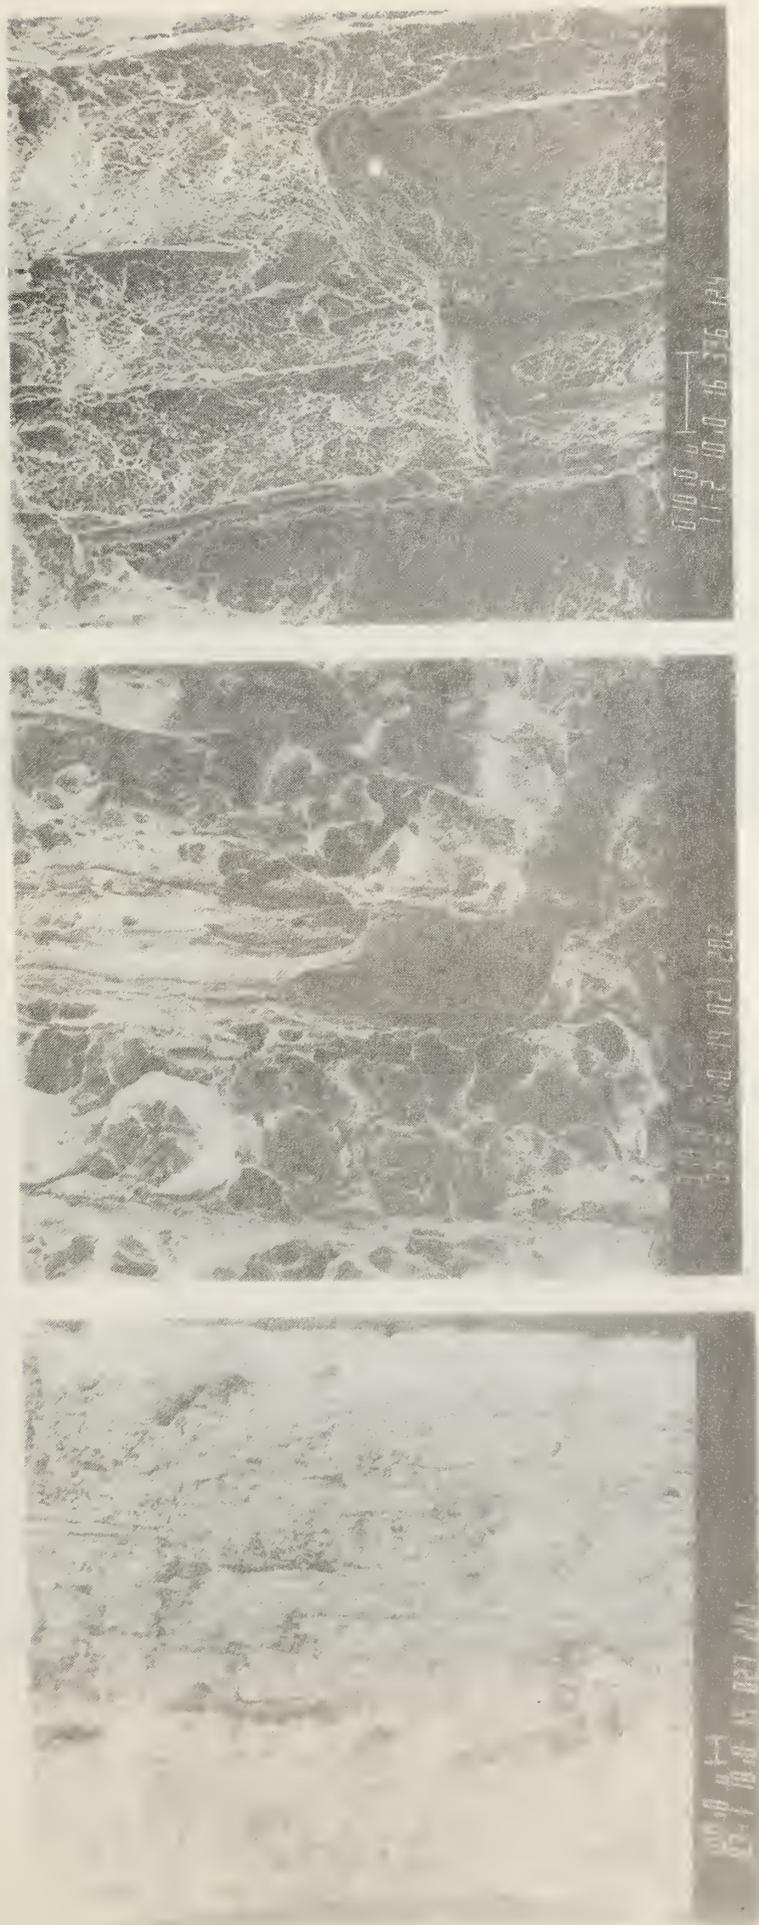
Figure 8.11 Fractographic appearance of hardened washer fractured in NBS test of walkway box beam 9M, washer installed at location 9MW (a). Center portion, area (b), reveals a mixture of brittle (intergranular and cleavage) and ductile fracture. Area (c) reveals ductile rupture through a decarburized surface layer. Elongated features are indicative of MnS stringers. Magnifications (a) X35, (b) X550, (c) X1050.

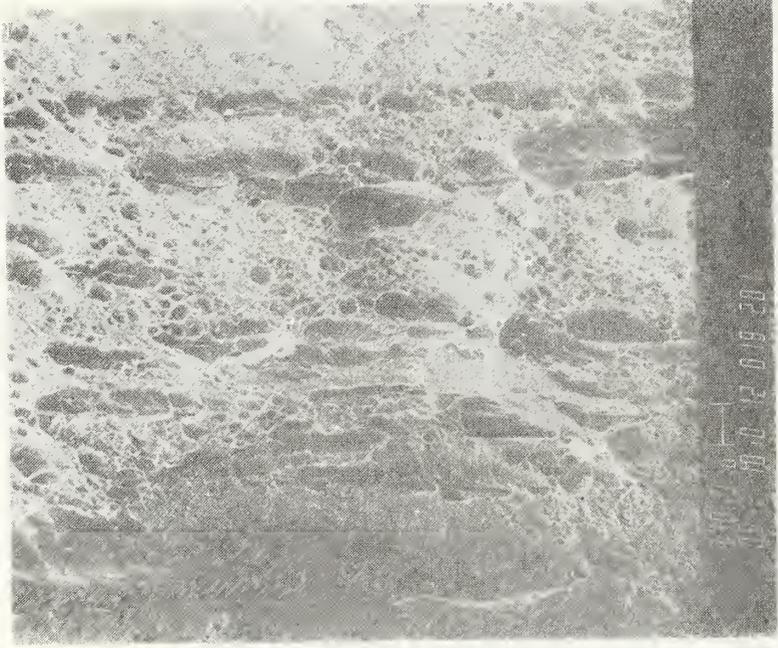
Figure 8.12 Fractographic appearance of walkway washer fractured in NBS test of box beam 9M (specimen KCl). Lower magnification view (a) shows high density of MnS stringers oriented parallel to the bend axis. Higher magnification view of center portion (b) shows mostly ductile rupture. Magnification (a) X25, (b) X550.

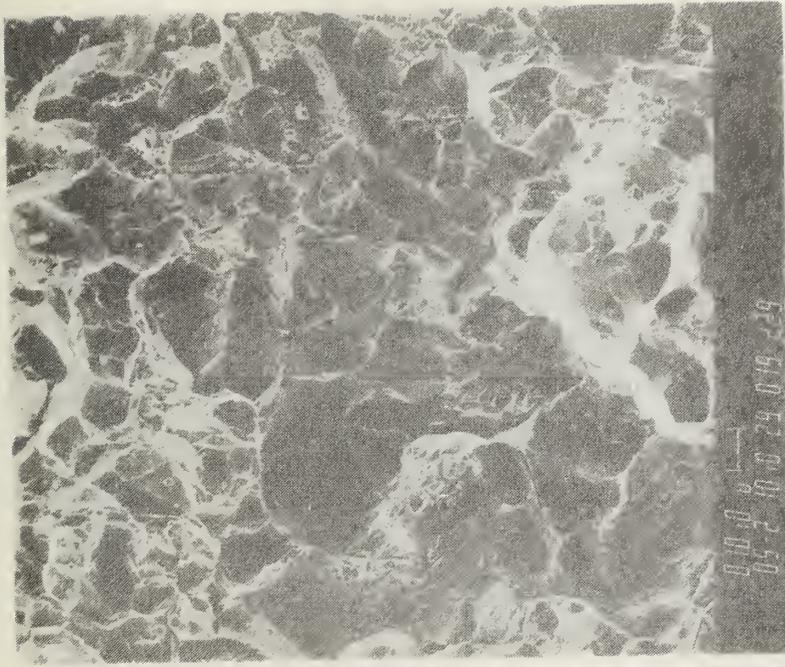
Figure 8.13 Fractographic appearance of walkway washer from upper end of hanger rod at location 9UE (NBS 11B) broken at NBS. Lower magnification view (a) shows no prominent MnS inclusions. Higher magnification view of center portion (b) shows essentially brittle intergranular fracture with a small amount of ductile rupture. Magnification (a) X25, (b) X550.

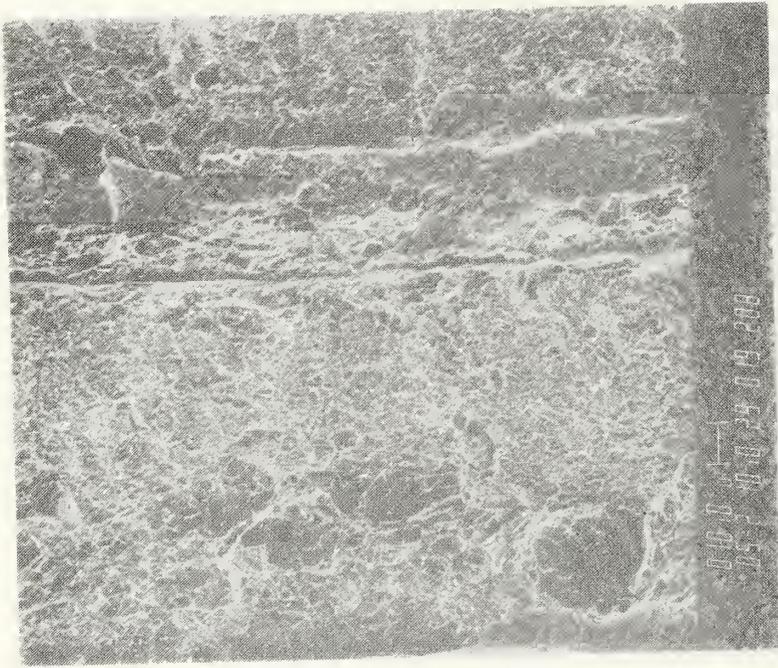
Figure 8.14 Fractographic appearance of NBS washer No. 3 broken at NBS. Low magnification view (a) shows elongated MnS inclusions. Higher magnification view of center portion (b) shows essentially ductile rupture. Magnification (a) X25, (b) X550.

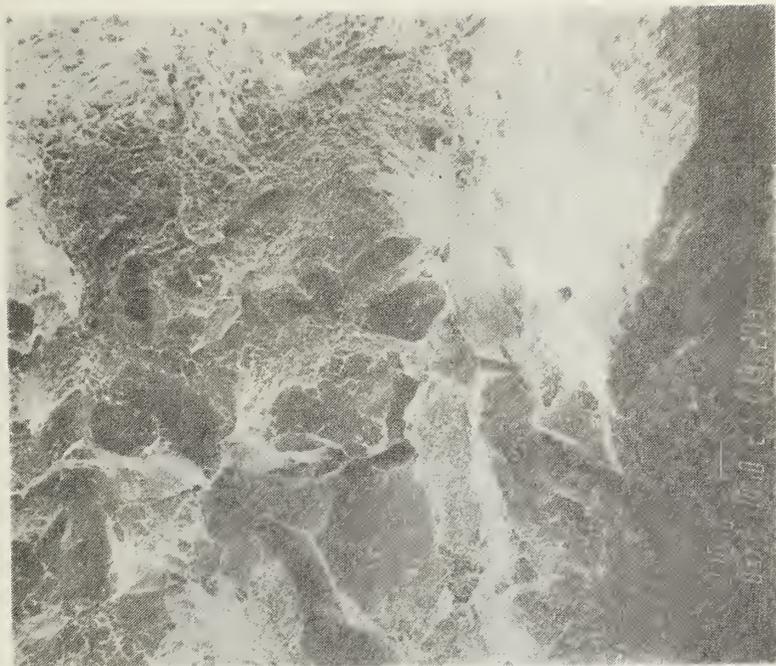
Figure 8.15 Fractographic appearance of NBS washer No. 2 broken at NBS. Low magnification view (a) shows no prominent MnS inclusions. Higher magnification view of center portion (b) shows 15-20 percent brittle intergranular fracture along with ductile rupture. Magnification (a) X35, (b) X550.

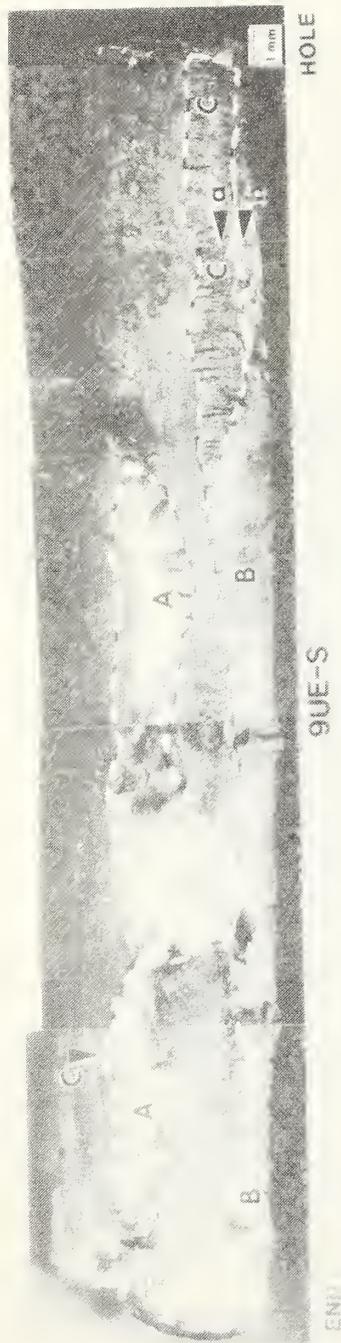
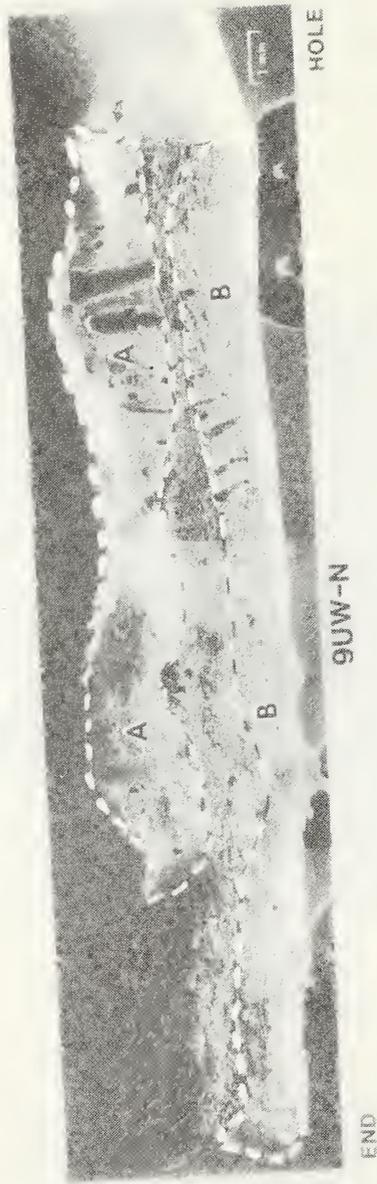
Figure 8.18 One half of box beam lower fracture surface between beam end and outer hanger rod hole.

(A) fracture area of the interior tack weld, (B) exterior longitudinal weld, (C) preexisting crack regions. This designation also is applicable to figures 8.19, 8.20, and 8.21. (a) and (b) noted by arrows on 9UE, indicate locations of figures 8.22 (a) and (b), respectively.

(a) location 9UE - S (optical, magnification X4.5)

(b) location 9UW - N (SEM, magnification X6.5)

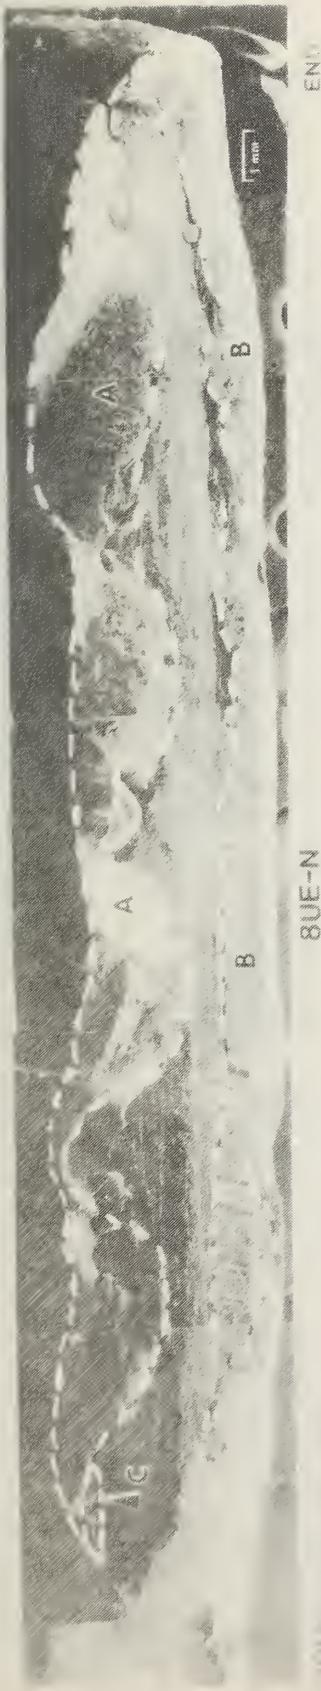
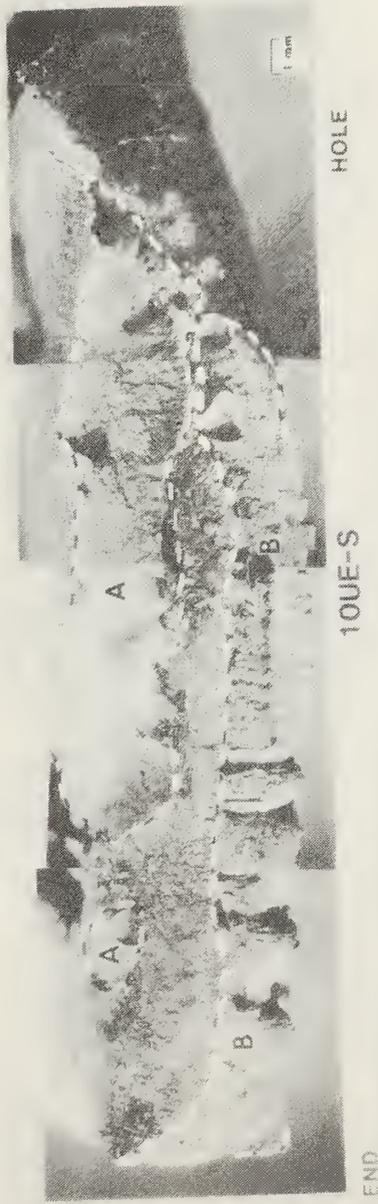
Figure 8.19 One half of box beam lower fracture surface between beam end and outer hanger rod hole.  
 (a) location 8UE - N (SEM, magnification X6.5)  
 (b) location 10UE - S (optical, magnification X4.5)

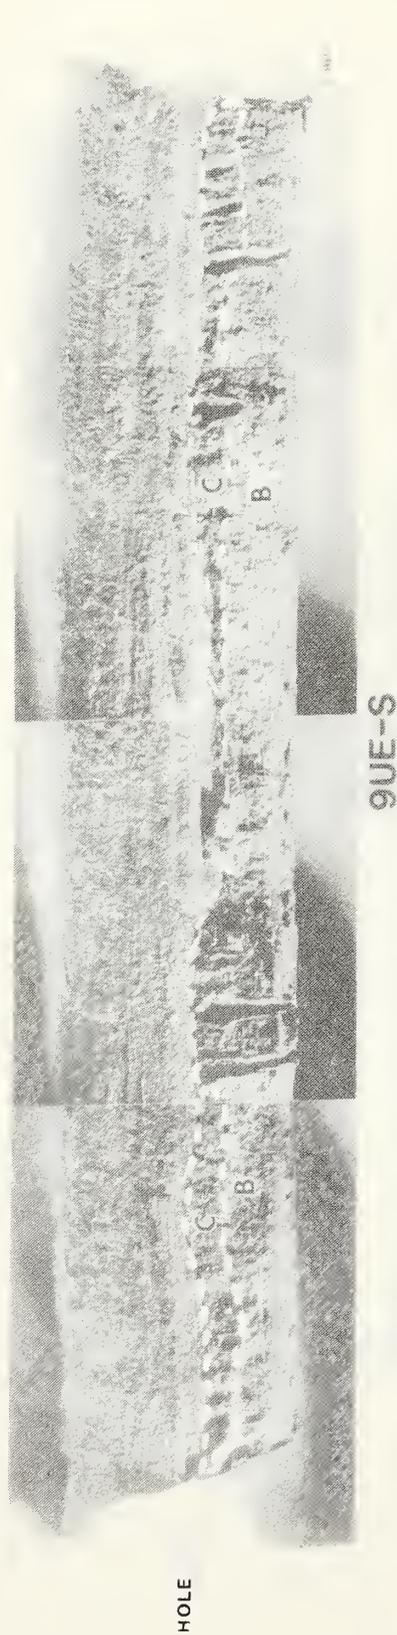
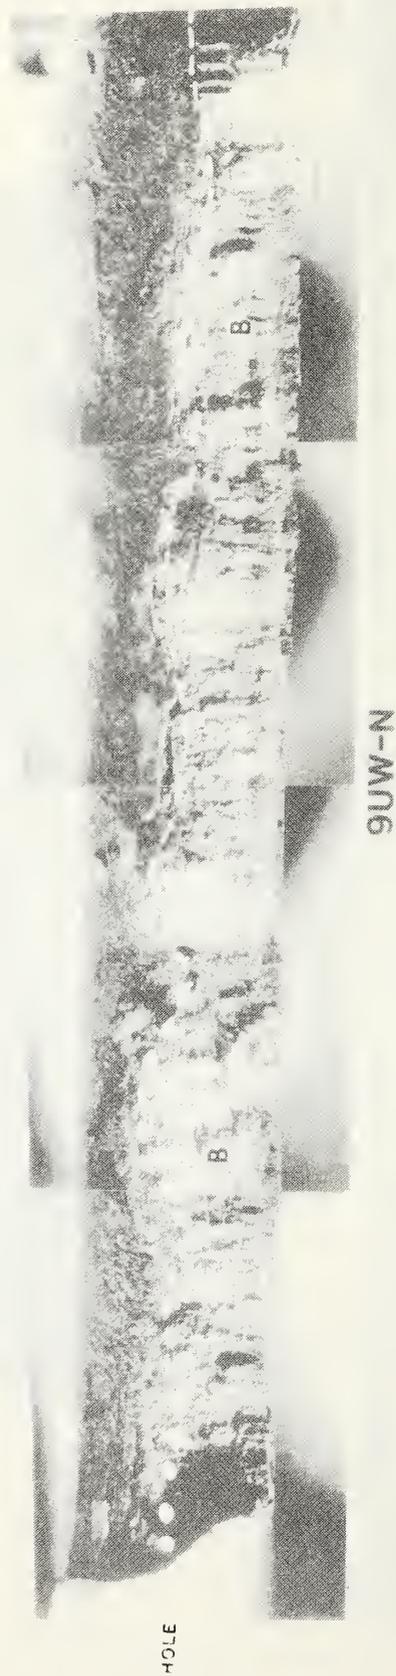
Figure 8.20 One half of box beam lower fracture surface between outer and inner hanger rod holes.

(a) location 9UE - S (optical, magnification X5.5)

(b) location 9UW - N (optical, magnification X5.5)

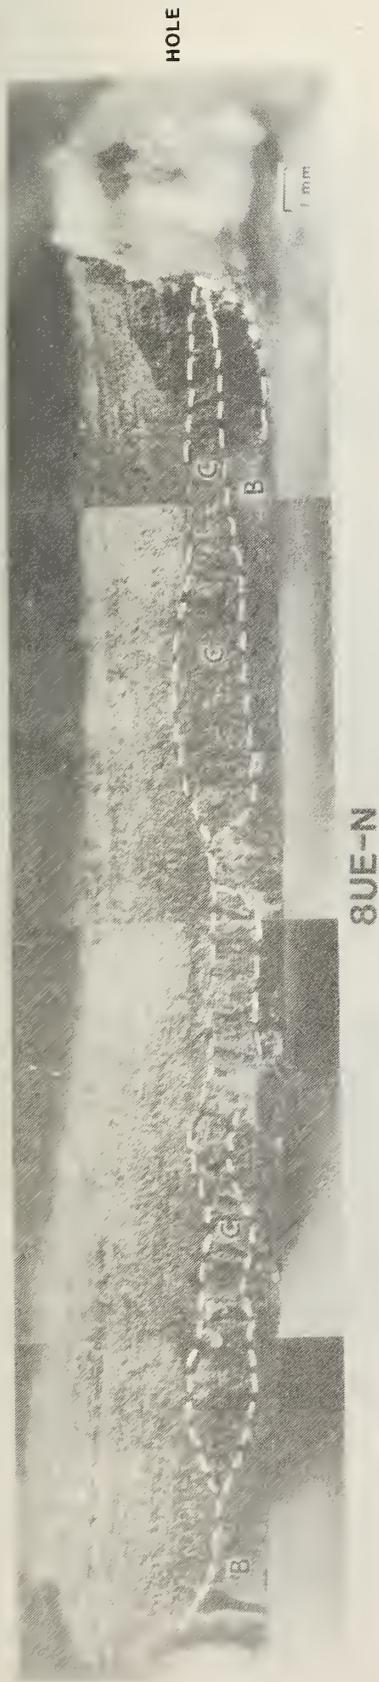
(a) location 8UE - N (optical, magnification X5.5)

(b) location 10UE - S (optical, magnification X5.5)

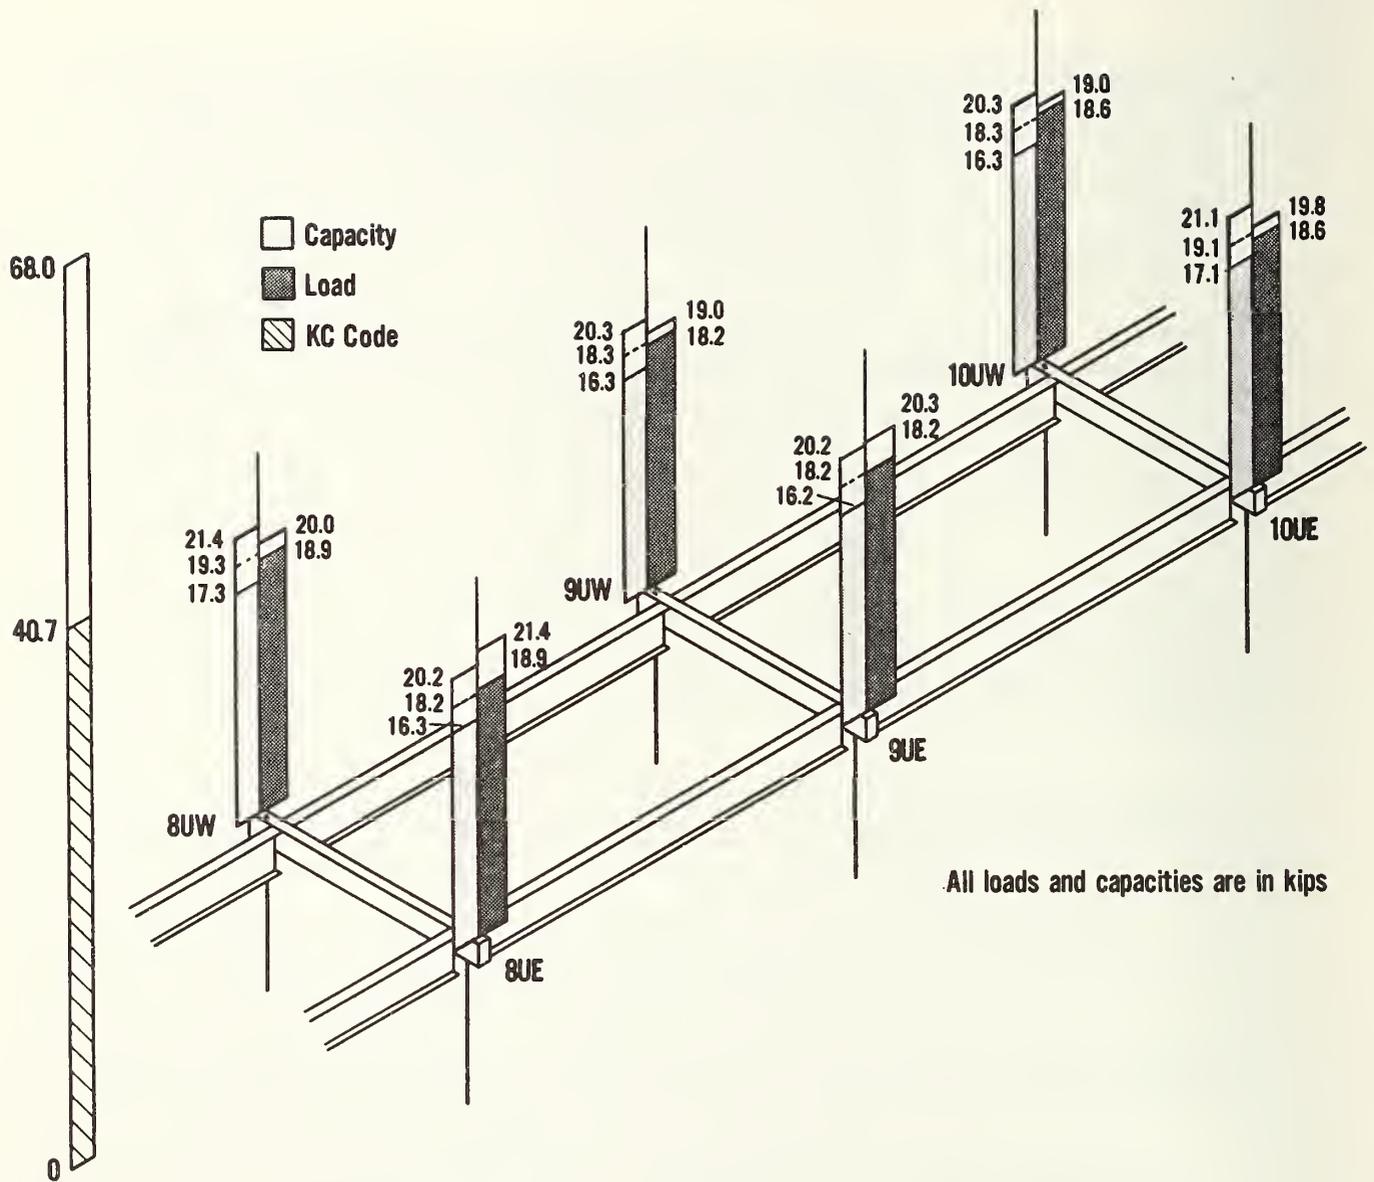
Figure 10.1 presents similar information for the other fourth floor box beam-hanger rod connections. This figure shows that, with the exception of locations 8UE and 10UW, the estimated mean ultimate capacity of each fourth floor box beam-hanger rod connection either equals or slightly exceeds the estimated dead load effect. However, the estimated mean ultimate capacity is exceeded by the sum of the estimated dead load and upper-bound live load in every case.

Figure 10.1 Comparison of fourth floor walkway box beam-hanger rod connection capacities with loads believed to have been acting at time of collapse.

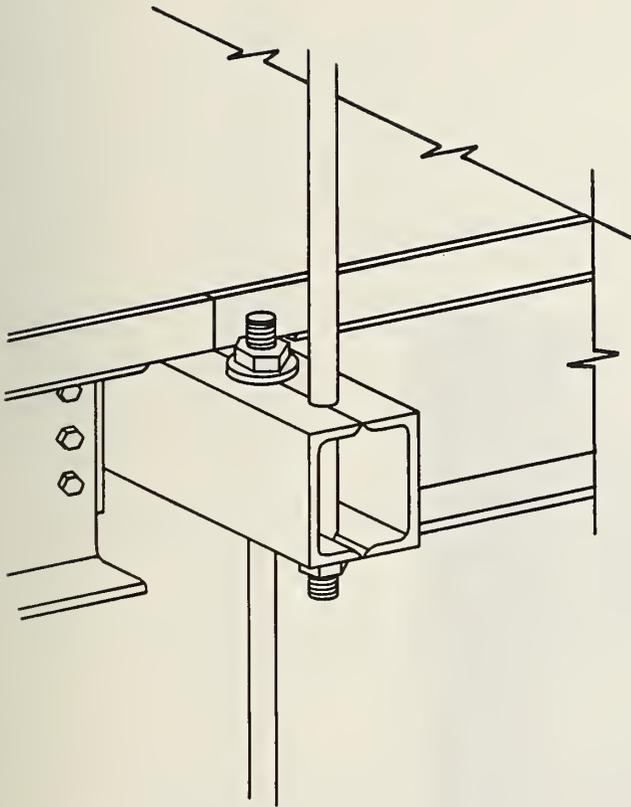
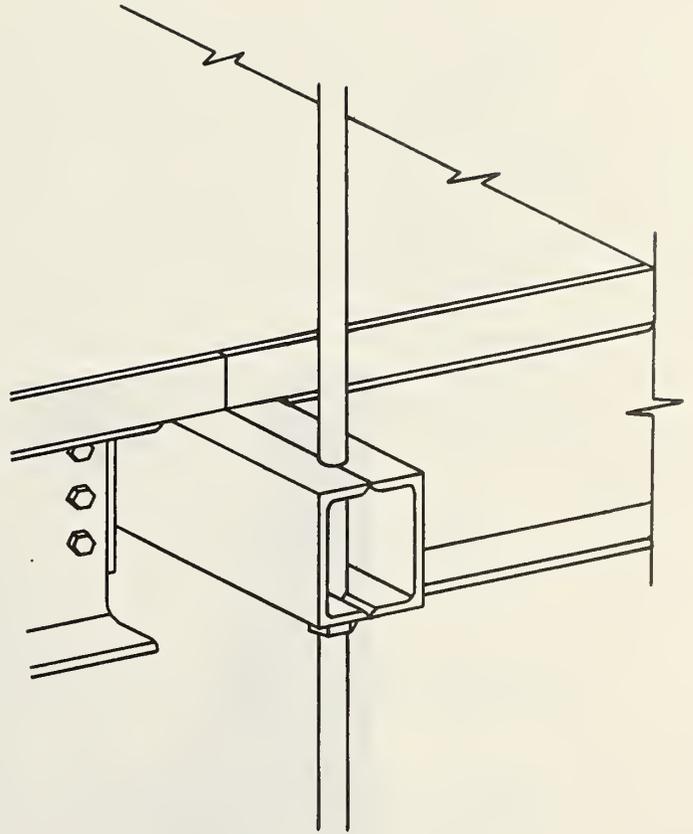
As has been described in chapter 3, the hanger rod configuration actually used consisted of two hanger rods: the fourth floor to ceiling hanger rod segment as originally detailed and the second to fourth floor segment offset 4 in (102 mm) inward along the axis of the box beam (see figure 10.2). The washer and nut arrangement called for in the original connection detail as shown on Dwg. S405.1 was retained in the actual construction. With this modification the design load to be transferred by each second floor box beam-hanger rod connection was unchanged, as were the loads in the upper and lower hanger rod segments. However, the load to be transferred from the fourth floor box beam to the upper hanger rod under this arrangement was essentially doubled, thus compounding an already critical condition. The design load for the fourth floor box beam-hanger rod connection would be 40.7 kips (181 kN) for this configuration.

Figure 10.2 Comparison of interrupted and continuous hanger rod details.

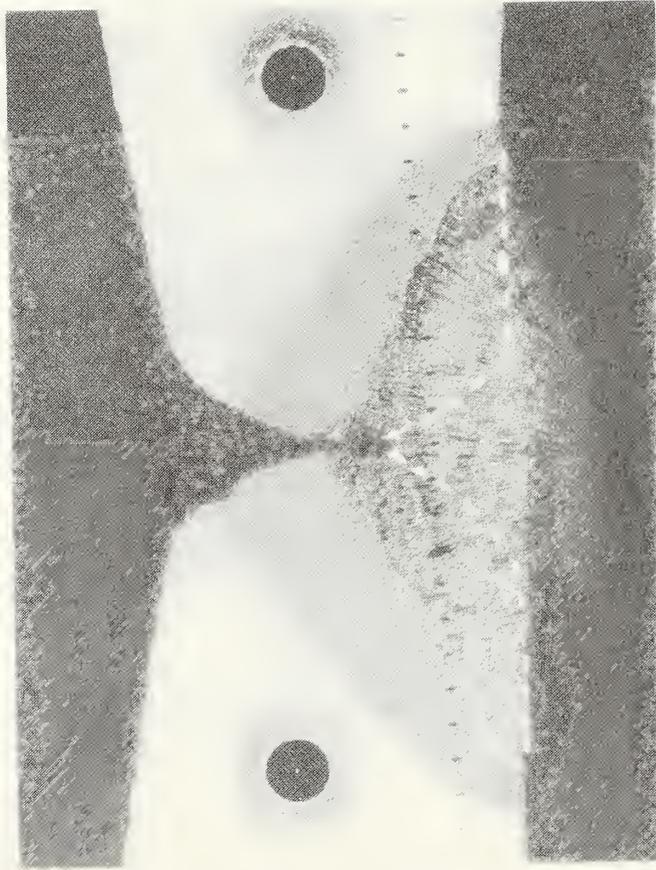
Figure 10.3 Cross section through weld region of walkway box beam 8L showing the exterior longitudinal weld joint at the bottom flange. Dotted lines indicate approximate original geometry of the flange toes. X8 1/2
